Manhole Inspection Summary

Manhole # S45K2_009MH

Location Address: **1420 CEDDOX ST**

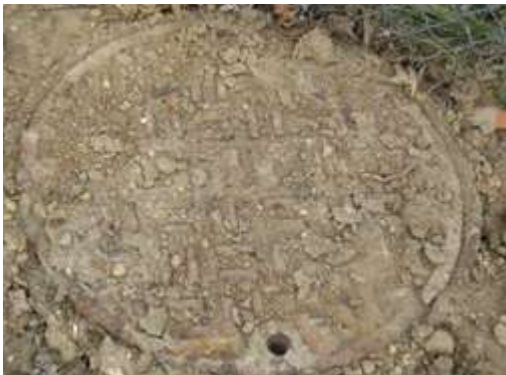
Condition: **Sound**

Cover Material: **Cast Iron**

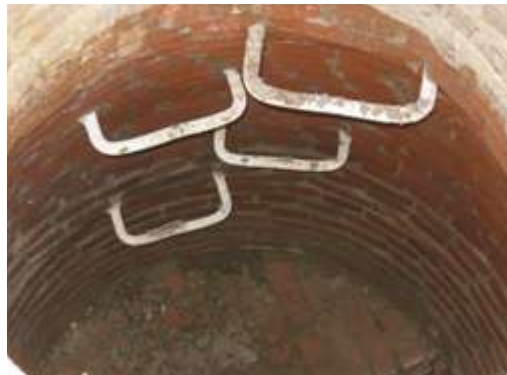
Steps Count: **4** Missing: **0** ☐ Corroded

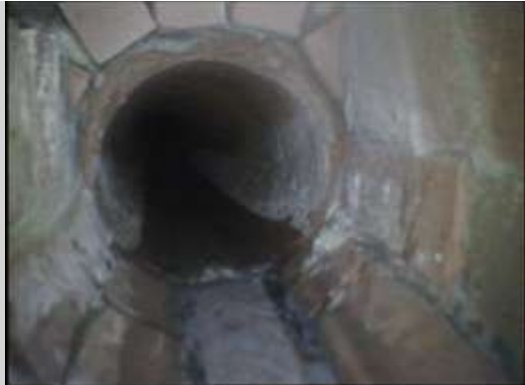
12 O'Clock Outflow

8 in. Circular Gravity Sewer
Pipe Out @ 12 O'Clock

Pipe Height: **12** (in.) Rod and Bar (Angled)
Pipe Material: **Unknown** ☐ Pipe Lined
Invert Depth: **9.45** (ft.) Flow Characteristics: **Slow**
Deposits: ☒ None ☐ Mud ☐ Sludge ☐ Debris ☐ Grease
Silt Depth: (in.) Deposits Extent:
Infiltration: **None** Pipe Seal Cond: **Sound**

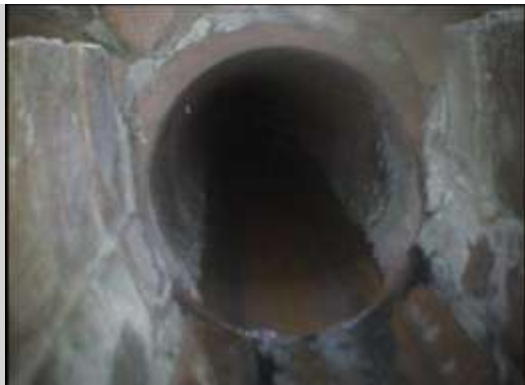
7 O'Clock Inflow

8 in. Circular Gravity Sewer
Pipe In @ 7 O'Clock

Pipe Height: **9.6** (in.) Rod and Bar (Angled)
Pipe Material: **Unknown** ☐ Pipe Lined
Invert Depth: **9.10** (ft.) Flow Characteristics: **Slow**
Deposits: ☒ None ☐ Mud ☐ Sludge ☐ Debris ☐ Grease
Silt Depth: (in.) Deposits Extent:
Infiltration: **None** Pipe Seal Cond: **Sound**
